## Rolfsan river, Sweden, 2005

New bridge over river and adjacent area decided as a conservation project by the road authorities. Aesthetical values important. Soil condition is sandy and running water up to 3 m/s, causing risk for erosion. For river bank protection we used both NAG C350 TRM and pre-vegetated coirbeds (KK-BED). Areas only temporary flooded are covered with coir ECB (KK-5). All area seeded and planted.

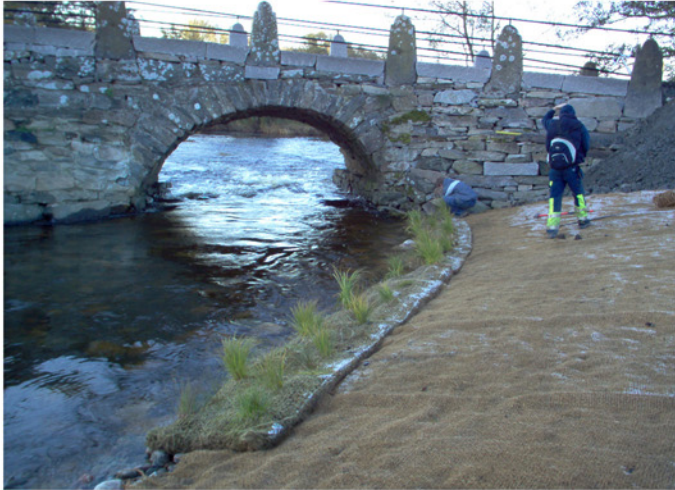
During installation

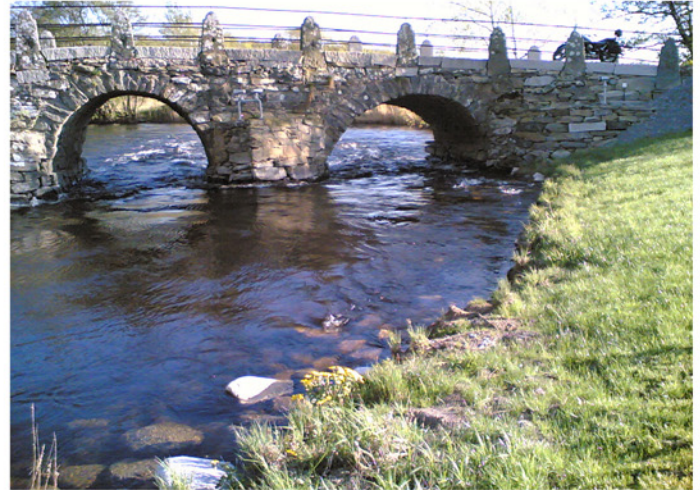
After installation

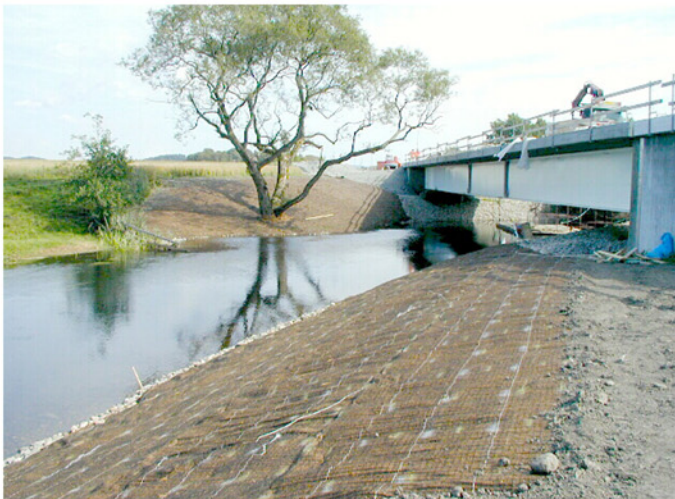
During installation

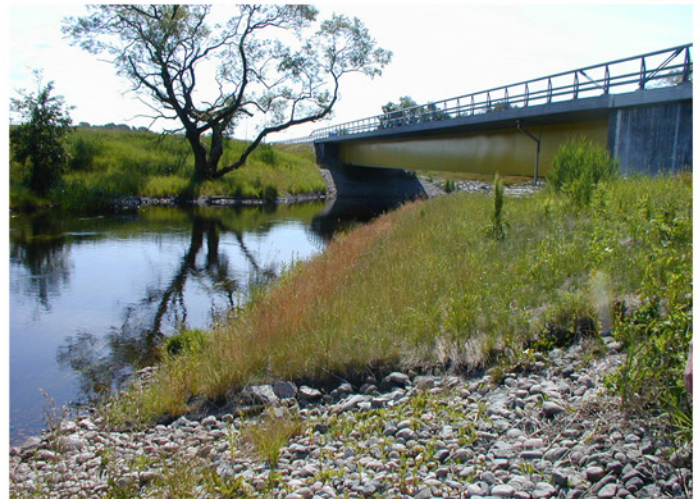
After installation
