Foss Dyke Bioengineering Works, Lincoln, UK

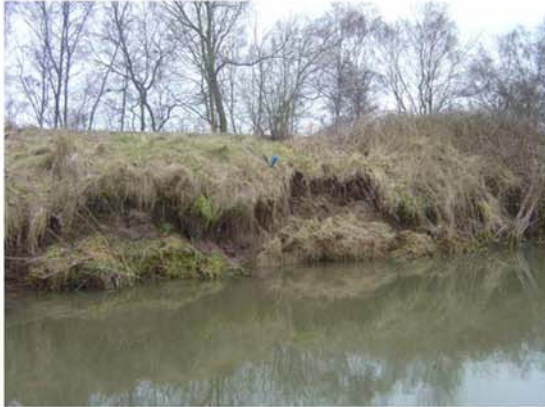
Above Left : Erosion on the Foss
Below : Brushwood fascines

The rail embankment that follows the Foss began to erode due to excessive boat wash (up to 2.5 metres in a year over a 2.5km stretch). Initial remedial works were planned to be hard revetments, Hard revetments, such as sheet piling or gabion baskets were considered but dismissed because of the ecologically sensitive nature of the site. King Fishers and Water Voles were recorded on the stretch of bank and therefore a bioengineering solution was required that could meet the vital engineering criteria but also enhance the marginal habitats for the Water Voles.

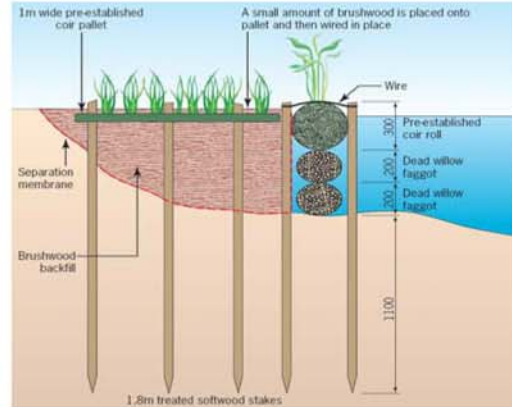
Above Right : Design Detail
Below : Works being Installed

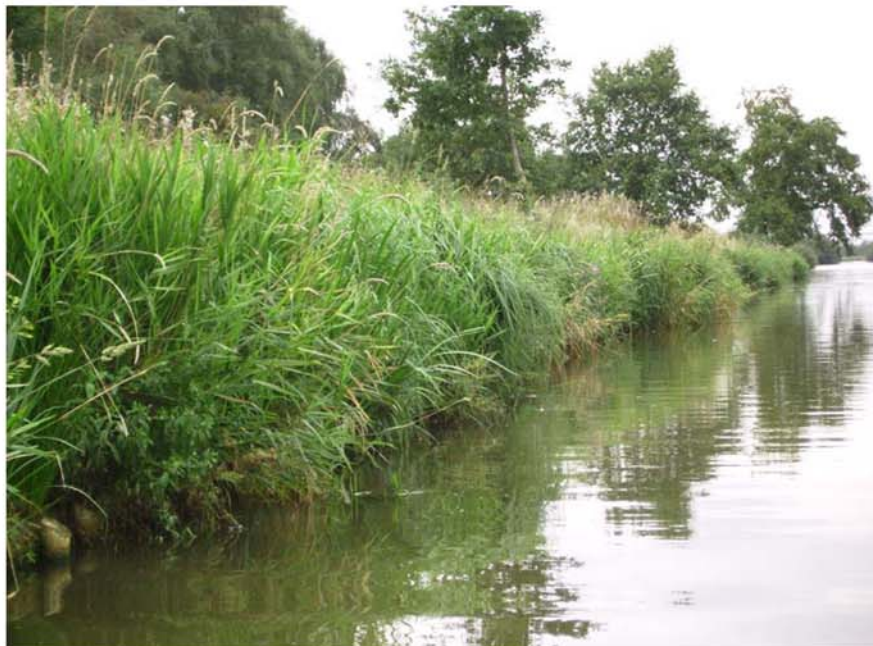
Above : Bioengineering works 5 months after completion
