E4, Hallunda, Lindvreten Sweden, 1997

Erosion protection of a high slope next to highway E4 south of Stockholm. Requirements from architects were that existing rocks would be visible after installation.

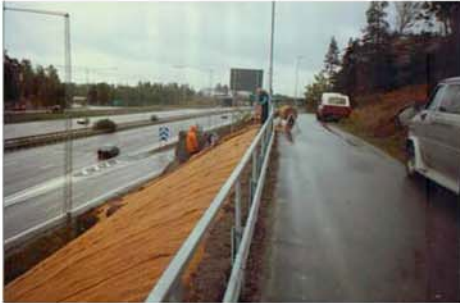
Installation 1997

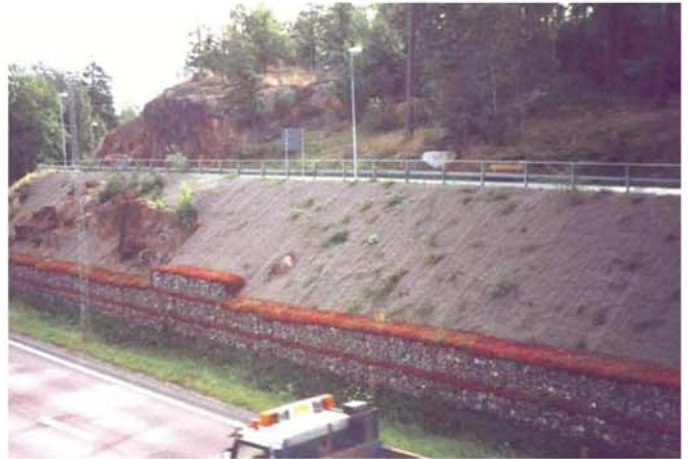
Gabions and coir geotextiles

A gabion wall was created as a basement, on top of which the slope was covered with coir geotextile which had to be placed around existing rocks to fulfil the desire of an aesthetic and technical solution of the erosion problem.

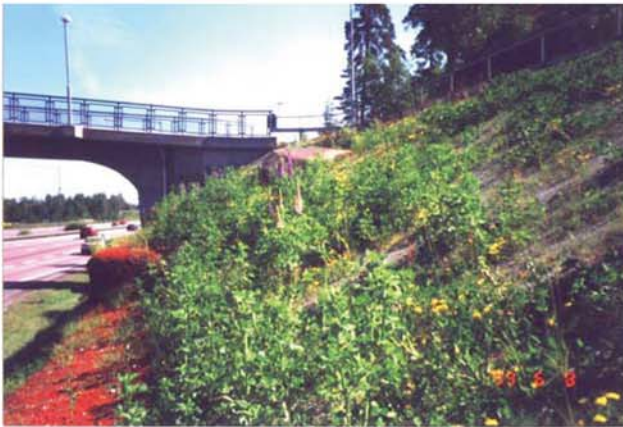
1,5 years after installation

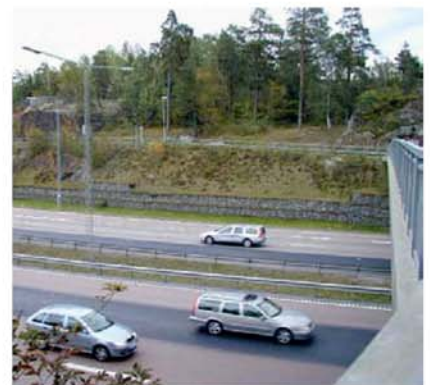
Installation well integrated in environment

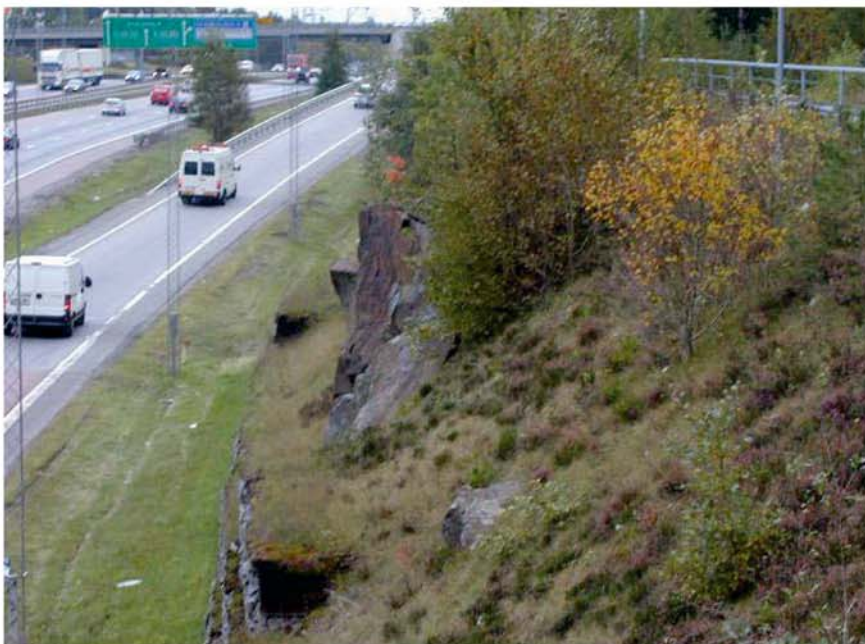
Visible rocks
