The embankment of a river in Nordrhein-Westfalen (Niers) shows heavy erosion. For the reconstruction At the base of the bank a rock-roll was installed. Then the slope was refilled with soil. In order to protect these section a permanent turf reinforcement mat was installed and fixed. These mats was pregrown with turf. So you have an immediate and - due to the special 3-dimensional structure of the mat – a long lasting protection.

Am Prallufer eines Flusses in Nordrhein-Westfalen (Niers) droht die fortschreitende Erosion einen Wanderweg zu unterspülen. Um die Böschung neu aufzubauen wurde zunächst am Böschungsfuß eine Steinwalze verlegt. Danach wurde der Bereich neu verfüllt und darüber anschließend eine vorbegrünte Erosionsschutzmatte verlegt. Durch die spezielle dreidimensionale Struktur der Matte werden Hochwässer schadlos überstanden.

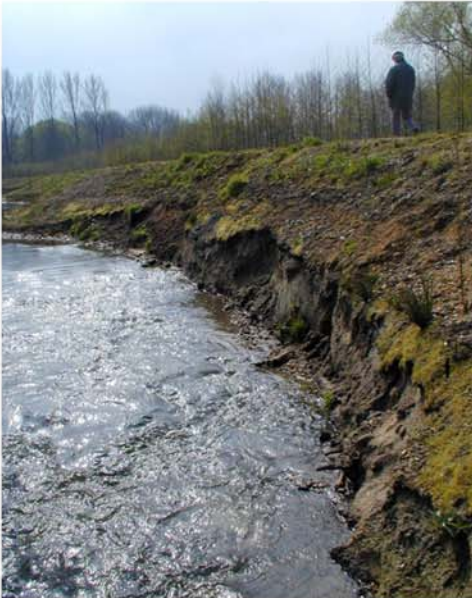
Uferabbrüche im Pralluferbereich
Erosion at the embankment

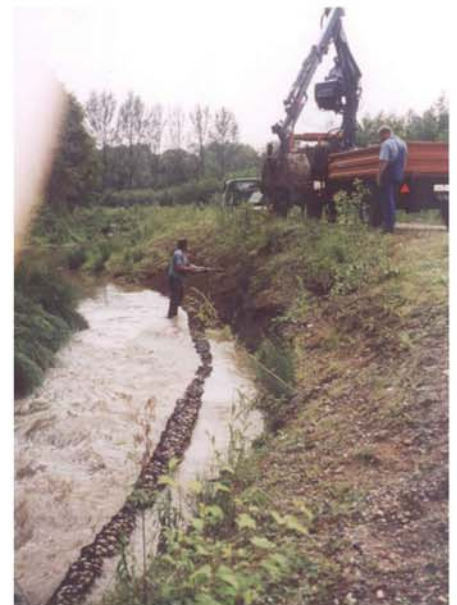
Am Böschungsfuß wird eine Steinwalze eingebaut.
Installation of a rock-roll at the base of the bank.

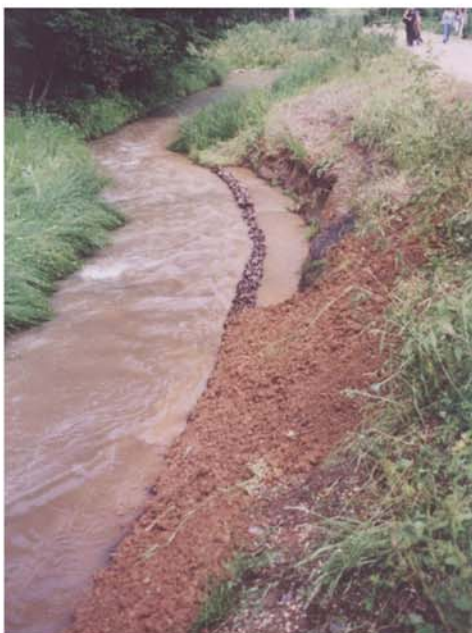
Neuaufbau der Böschung und Verfüllung mit Substrat
Refilling of the slope with soil

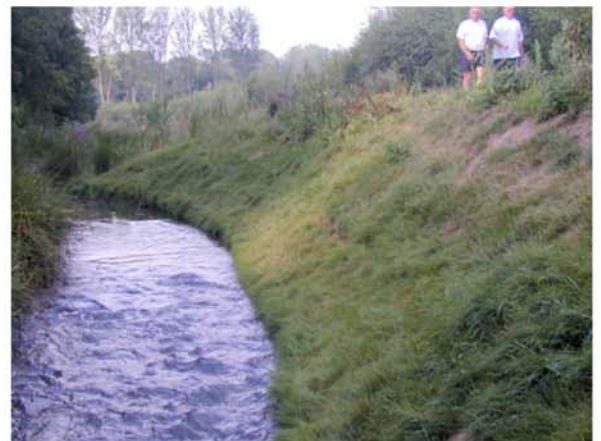
Entwicklung im ersten Jahr.
Development in the first year.
