PREPLANTED COIR ROLLS AT A BROOK IN THE SOUTH OF GERMANY / RÖHRICHTWALZEN AN EINEM BACH IN SÜDDEUTSCHLAND (HÜGELLAND)

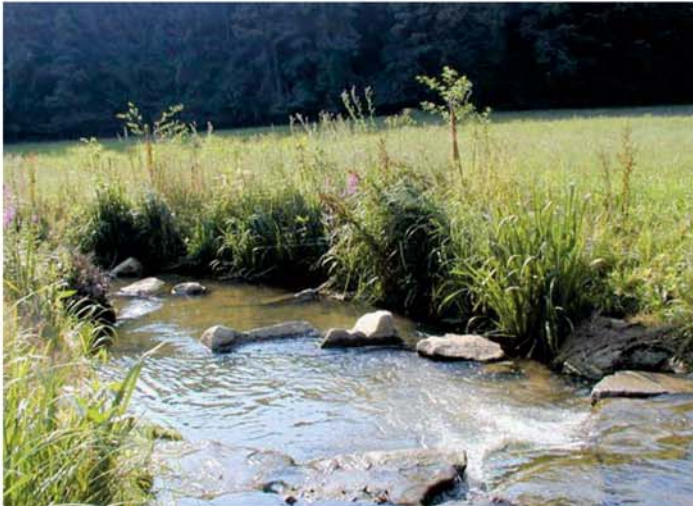
Die Entwicklung nach 2 Jahren
The development after 2 years

At a brook in the South of Germany different types of bank reinforcement were used. Here you see stones and preplanted coir rolls. With these rolls you have immediately established a wetland vegetation. It will cover and protect the whole slope. The two last pictures show the development after 2 years.

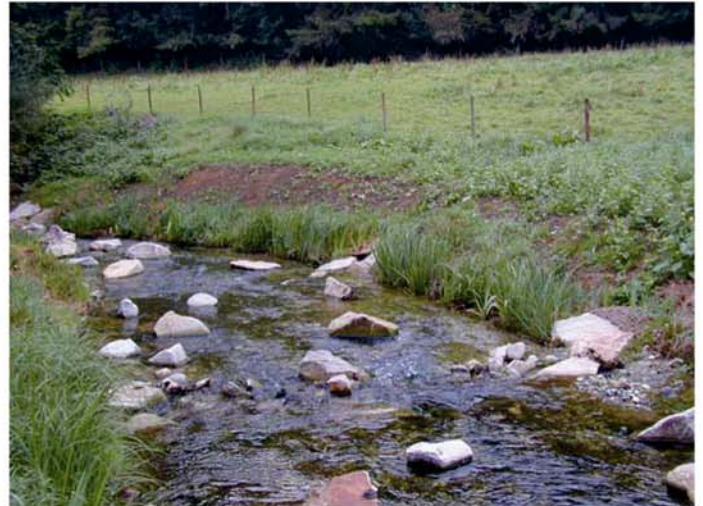
Auf dem rechten Ufer erkennt man die Röhrichtwalzen
At the right bank you see the preplanted rolls

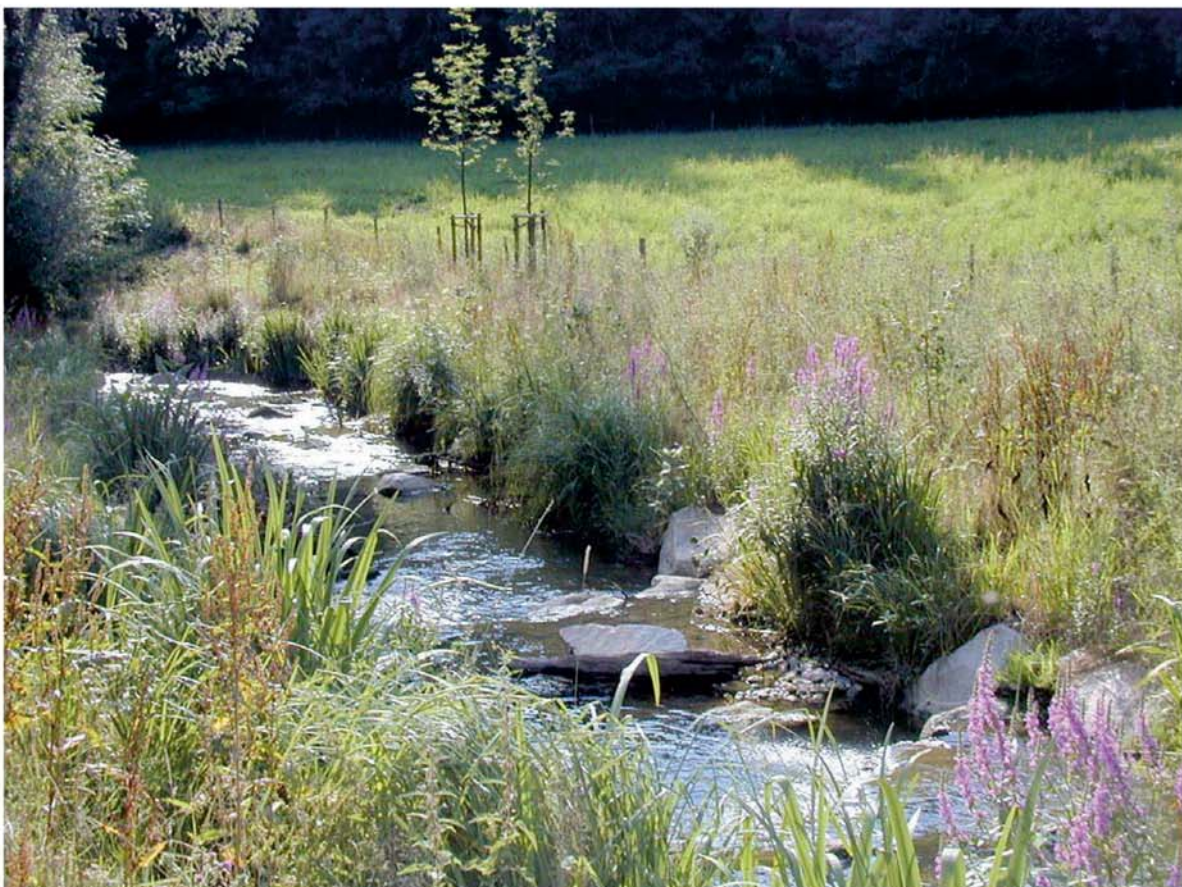
Steine und Pflanzen bilden eine Einheit / Stones and plants are a unit
